Richmond Refinery LPS Bulletin – Reliability

TKC P-713 Fire while P-713A Not Available

Location: Hydro ABU,
North Isomax TKC Plant

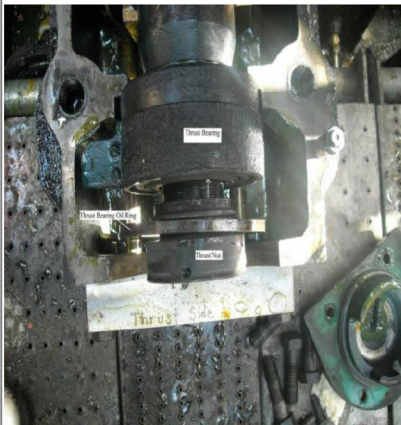
Thrust nut came off shaft

- 1) Lack of lock washer allowed the thrust nut to come off the shaft.
- 2) Pumps were operated below the minimum flow about 30% of the time in the last 9 months and 70% the week before the failure.
- 3) Both pumps had high vibrations at below-minimum flow rates.
- 4) Both pumps had failed thrust bearing and outboard seals this year.

- 1) Reinforce the need to evaluate the risk of potential threats by reviewing the investigation findings at a unit reliability brief.
- 2) Ensure the use of a robust thrust nut fastener design.

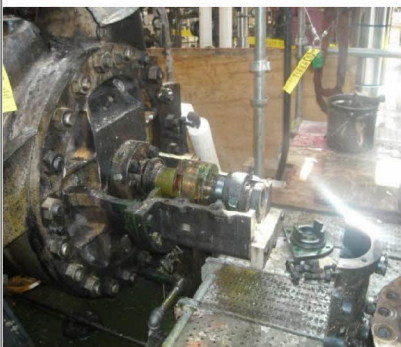
Failed thrust bearing
